**Hudson Bay Mining & Smelting Co., Limited**  
**Flin Flon Tailings Impoundment System**  
**Saskatchewan Government Annual Report – 2009**

**1. Introduction**

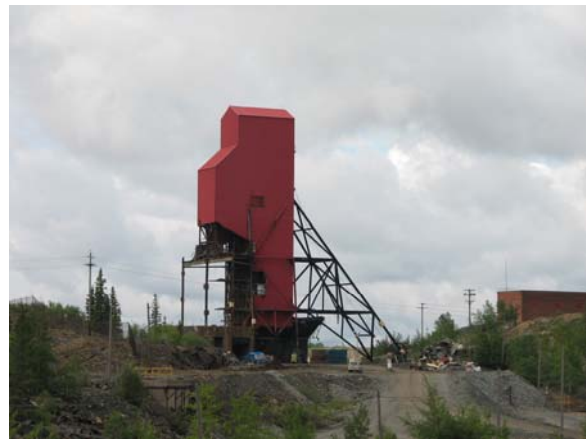
Work involved the removal of the South Main Headframe (pictured), the Changehouse, Water Tower, fuel storage area and several minor outbuildings.

Rehabilitation of the Callinan (South Main) Mine began in mid-2009. Rakowski Cartage and Wrecking was on-site from June through October to conduct demolition and clean-up work.
